LOWER GATE with BARBACAN

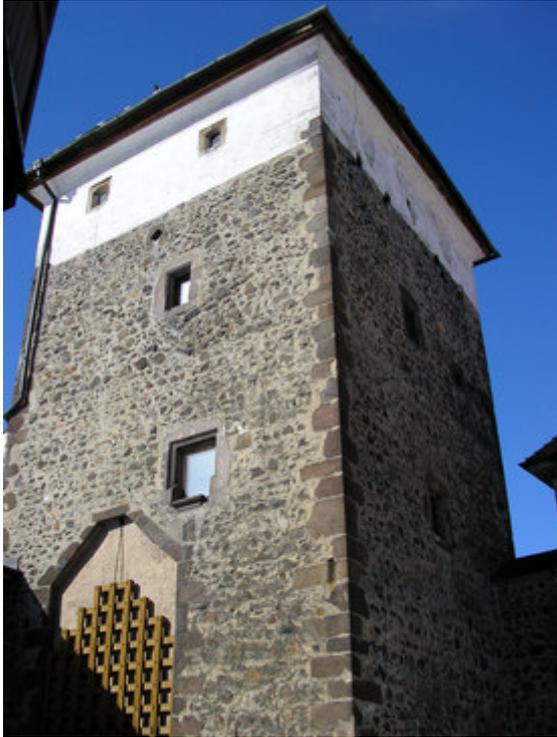
1. Lower gate with falling grating
2. view on Barbacan through Lower gate
3. Barbacan from the South
4. Barbacan from the North

One could come into the city using either one of the **three gates**. In the North (from Turiec) using **Upper gate**, through **Lower gate** from the South (from Šášov) and in the East using **Little Gate** (from Bystrica). The gates were an important part of the city fortification. They were in the form of high, multi-storey towers. In the base was a passage protected with a strong gate, a falling grating and a drawbridge.
