## THE NORTH TOWER and CHARNEL HOUSE

**Kremnica** was the seat of the mining chamber and its mint is known across the whole Europe. In the historical part of the city stands the city castle, fortified seat of both clerical and secular authority of the main royal mining town. The main building of the castle is The Church of Saint Catherine with tall tower. Around the castle is double fortification with bastions, a rotunda, clock tower, North Gate and a newer staircase, providing entry from the South. This complex of buildings and walls is **the most preserved medieval castle in Slovakia**. In the year 1950 was the whole area listed in the list of historical town reserve and since 1970, it is a **National monument**.

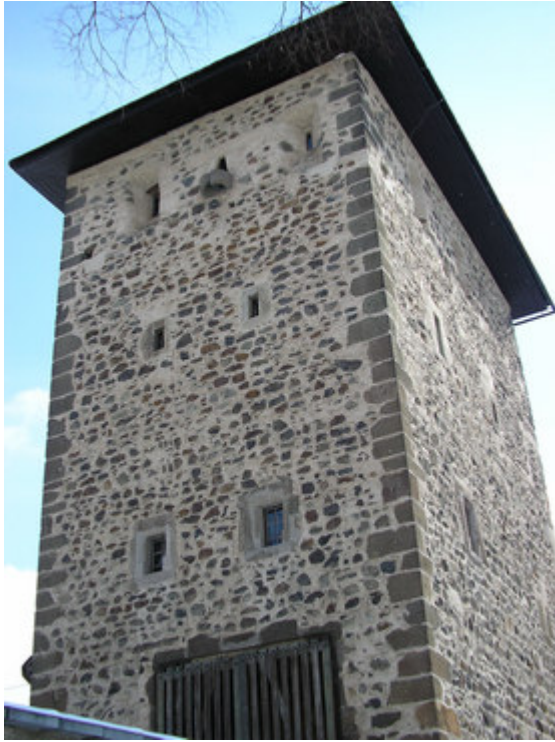
1. The North tower
2. Rotunda of the Saint Ondrej
3. North tower with stone bridge
4. The Gate of the North tower
5. view from the castle grounds

In the near vicinity of the rotunda is found an old entry gate to the castle area, so called **North Tower**. It was used in the past to enter the castle area only through this gate, using the wooden drawbridge across a deep moat. Later was the entrance changed to a stonemason bridge with pointed arch. Although this prismatic tower is a gothic building, the entrance portal has a semicircular opening.

The North Tower is a part of the initial **double fortification of the castle**. The castle wall is 90-120cm wide, with foundations deep 1.2-2 metres, built from quarry-stone. The **portholes** were scattered across all the sides of the North Tower. Nowadays, only the portholes on the face side together with the **opening** for throwing blazing tar or water on enemy are preserved.
